Public Environmental Report:

Dulverton Organic Recycling Facility (EPN 7852/1)

June 2014 to June 2017

Dulverton Waste Management

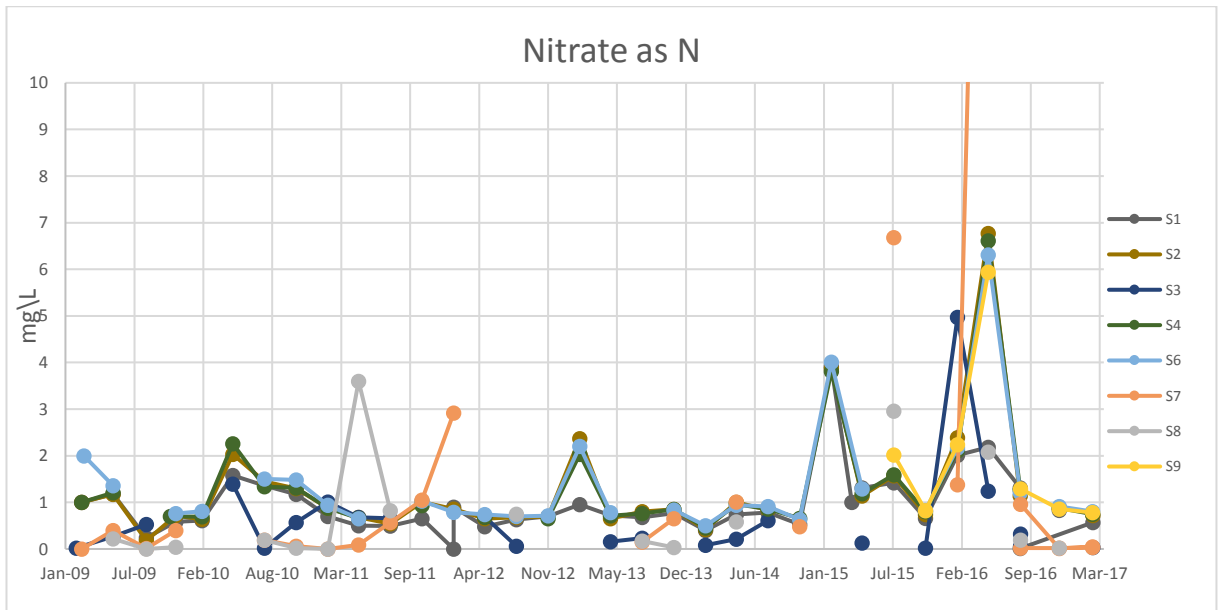
Figure 3 Historic and recent Nitrate Results from the Surface Water Sites

The nitrate values from the most recent monitoring rounds (August 2016 – present) are well within the historical values recorded (Figure 3). The sampling sites would appear to show a good correlation between one another with rising nitrate levels including the background site S9. The exact sampling dates for the May 2016 and February 2015 are not recorded in the data set however there were days rainfall in excess of 25 mm that may have resulted in a flushing effect from the broader catchment.
